# Crashworthiness of buses

## Analysis of European data and suggestions for improvements

2082/2025

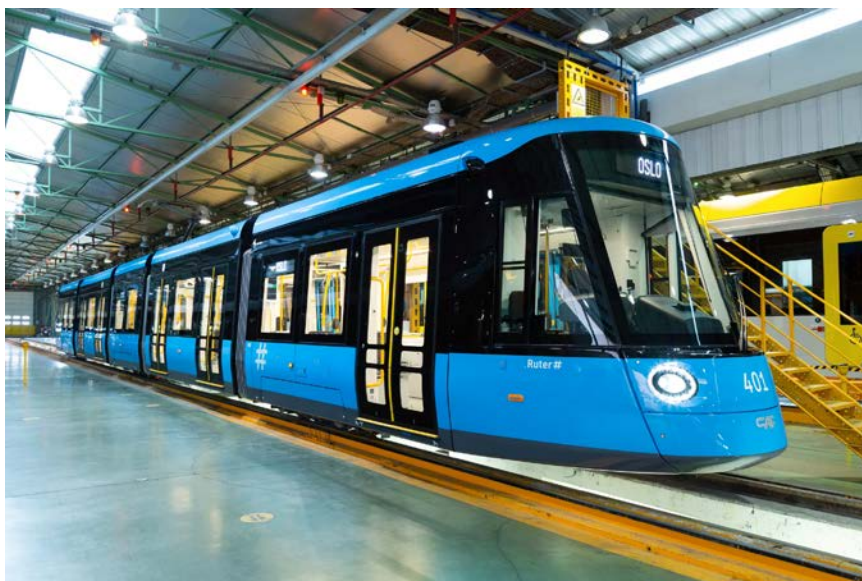
Figure 5.3. Front design of new trams introduced in Oslo 2022-2024

Martin et al. (2020) found that a rounded bus front reduced the number of pedestrians who were run over by buses. In this context, the front of the bus was only slightly rounded and slightly backward leaning. It seems logical that a better protection of the driver can be attained by adopting the more extreme version of front design shown in Figure 5.3.

Making the front of a bus round and backward leading may add a little to the length of the bus compared to a bus with a vertical front. It may also add a little weight. However, so does adding the safety beams required by R29.03 and R93.00. The inside of a rounded and backward leaning bus front need not contain any heavy structures. Indeed, it would probably be advantageous if it did not do so, but simply crumbled upon impact. There should be something similar to the fire wall in a car engine to the rear of the rounded section to prevent it from intruding the driver's compartment or at least reduce the amount of intrusion.
