Crashworthiness of buses: Analysis of European data and suggestions for improvements

PhD. Tor-Olav Nævestad, head of research group
Safety and resilience, Institute of Transport
Economics

Crashworthiness of buses

Analysis of European data and suggestions for improvements

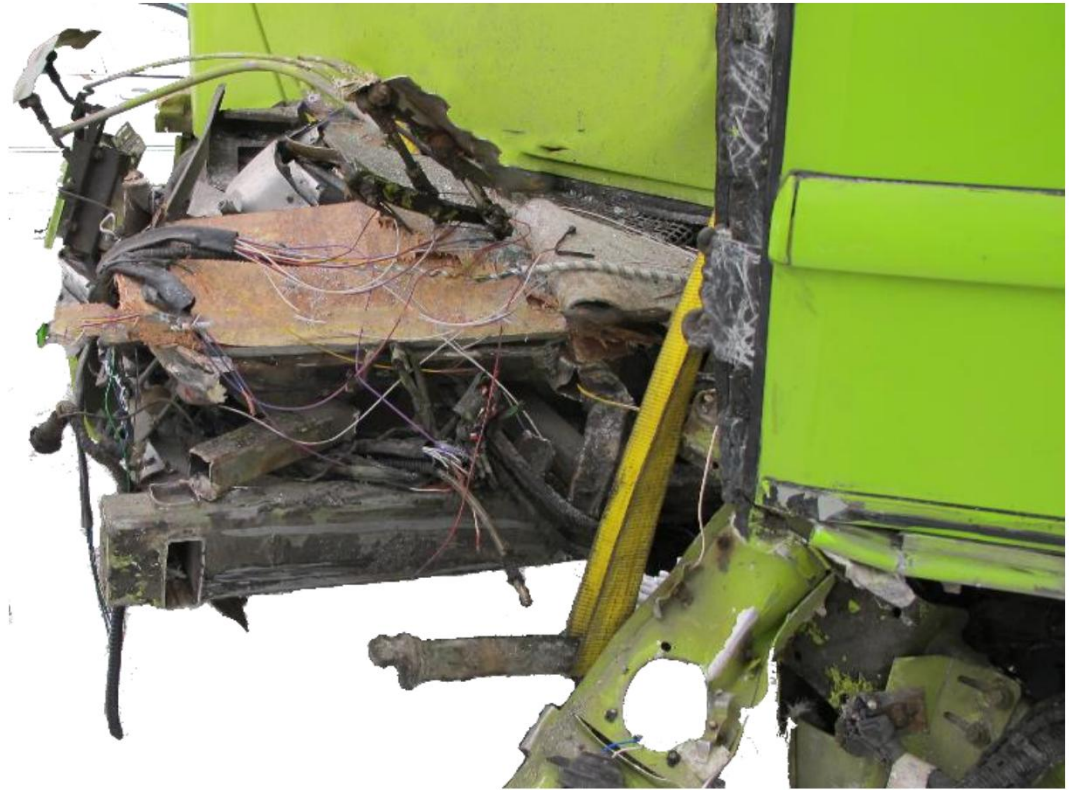
Figure 6: Cross-beam severed on the left-hand side, seen from the side. Photo: AIBN

- 5) **Reinforcement of the roof.** The AIBN reports show that in all of them, the upper roof connection was detached from the lateral structure.

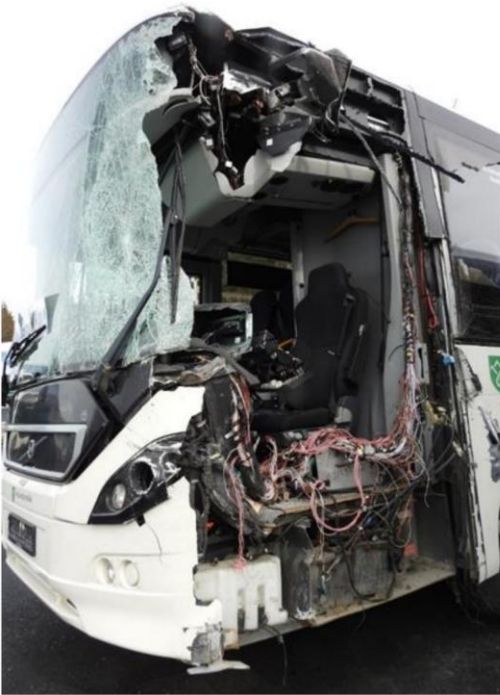
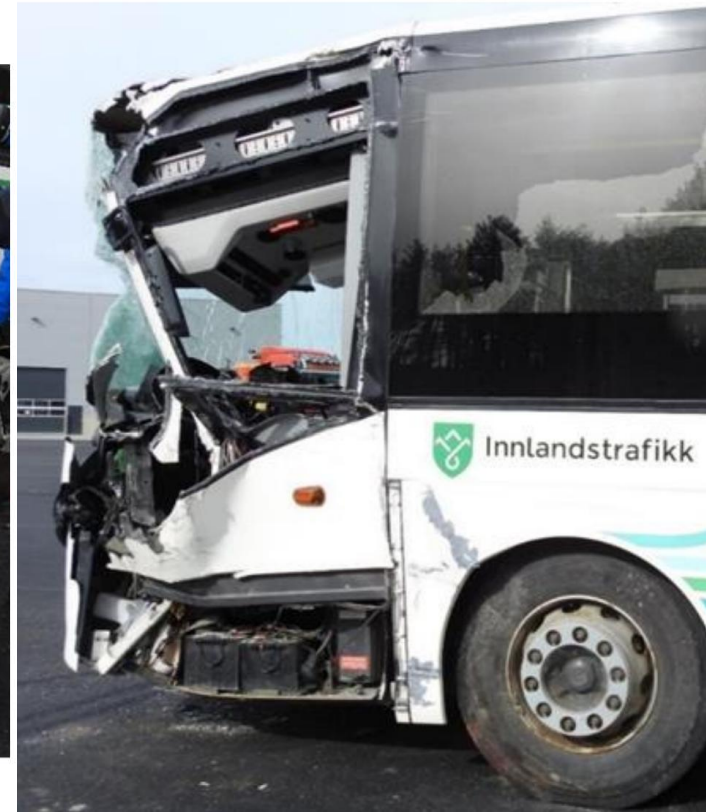
Tangen 2021: Fatal head on accident with two buses, around 35- 50 km/h

Figur 11: Skader foran på enhet B. Foto: SHK

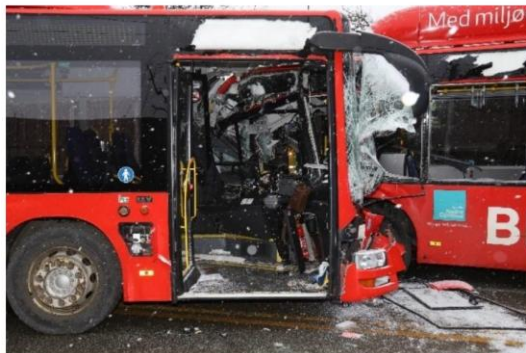
Figur 5: Buss 5 sett fra siden. Foto: Politiet
